AVIATION INVESTIGATION REPORT
A03P0259

NAVIGATIONAL ERROR – PREMATURE DESCENT

AIR CANADA
AIRBUS A319-114 C-FYKW
VERNON, BRITISH COLUMBIA
23 AUGUST 2003

Report Number A03P0259

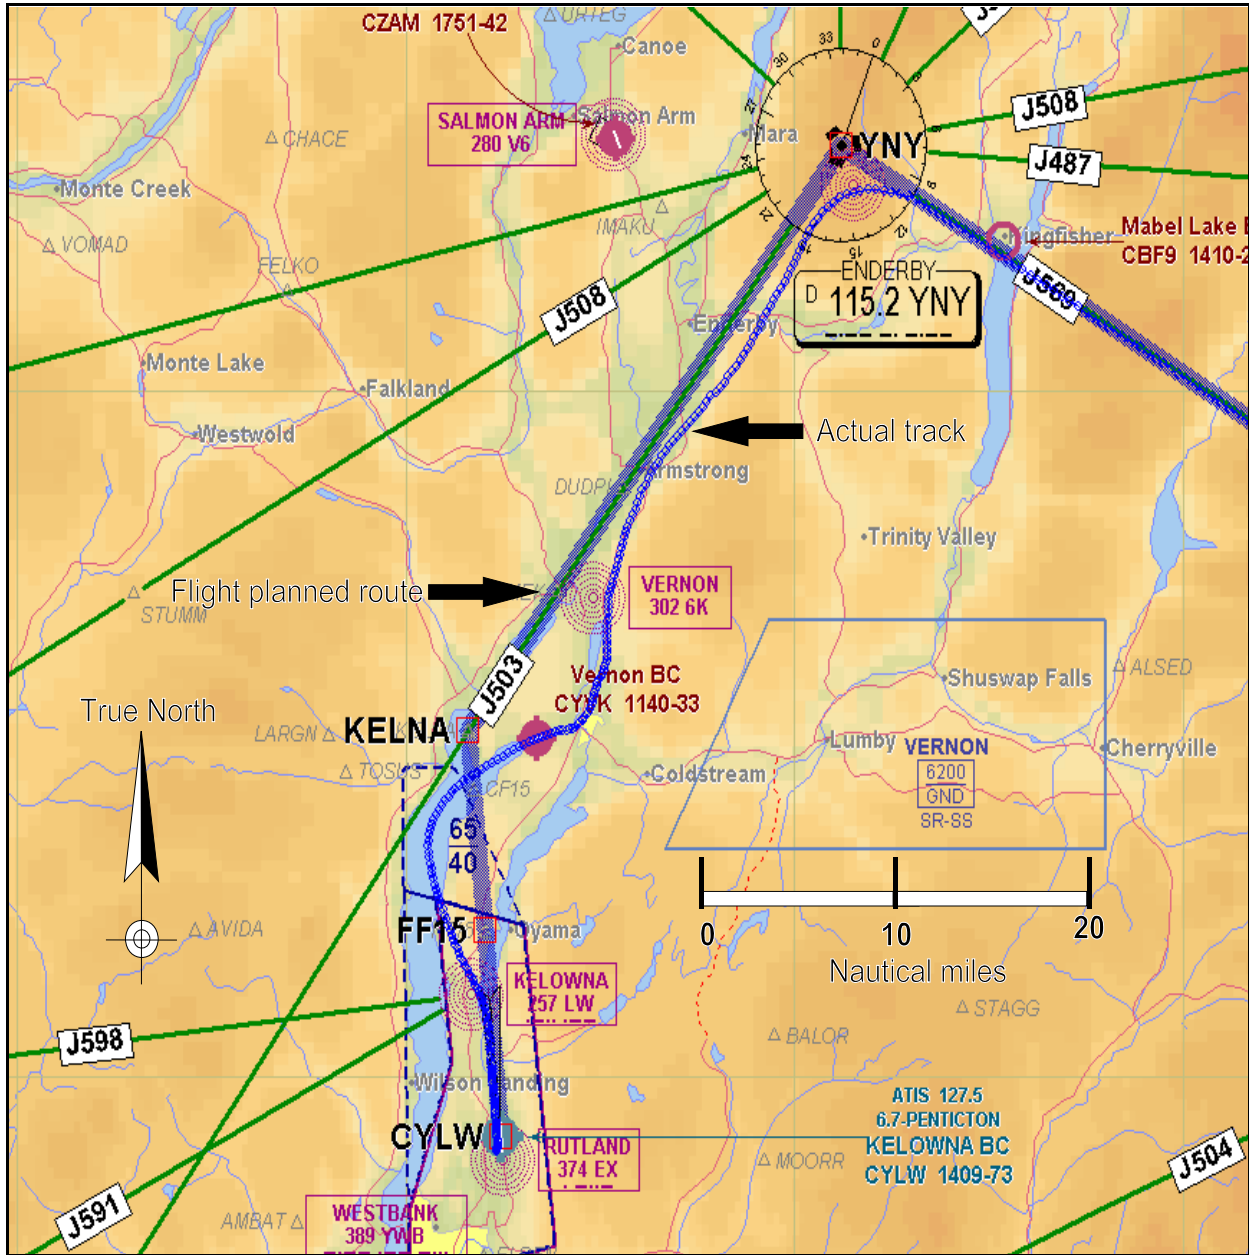
Appendix A – Track of Air Canada 183

It was concluded from information gathered from the FDR data and some flight simulations that when the Vernon airport came into view, the captain misidentified it as the Kelowna Airport and turned the aircraft to the right to line up with the centreline of Runway 23 at Vernon. Neither crew member noted that the aircraft heading and the runway heading were 80 degrees off the intended landing runway, Runway 15, nor did they make effective use of the aircraft's navigation system during the approach. The first officer, although unfamiliar with the area, was aware from his cockpit displays that considerable distance remained to the Kelowna Airport. He was, however, initially distracted by radio calls with company personnel and was slow to intervene in the approach to the Vernon Airport.
